Milestone Phase One Inspection Report
 Ocean and Racquet Condominium Association - Building 1

June 30, 2023

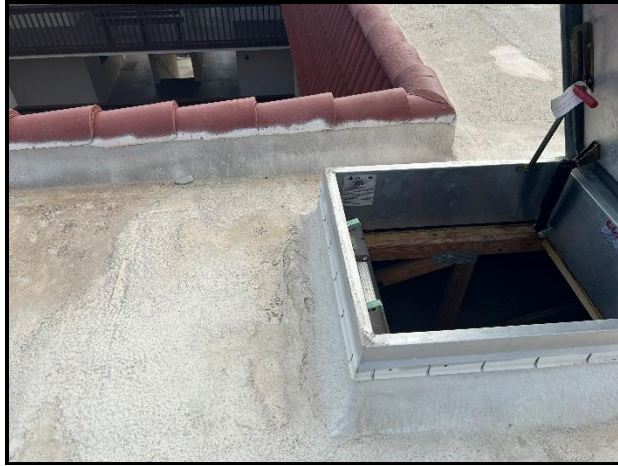
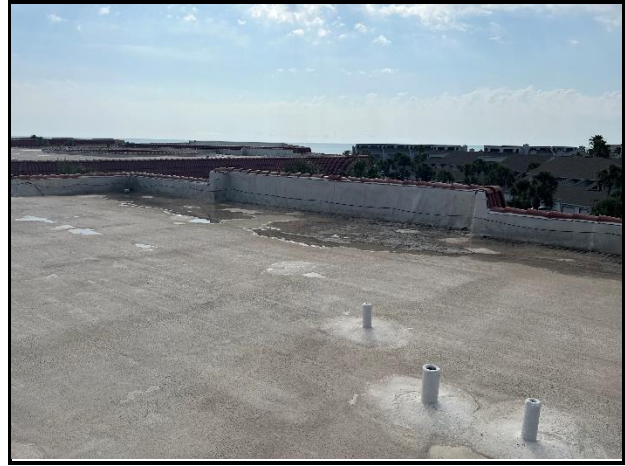
Roof access is located close to the roof edge. Recommend a safety guardrail in this location.

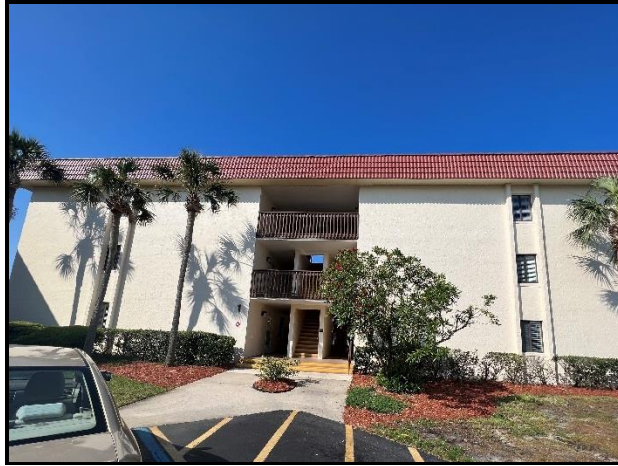
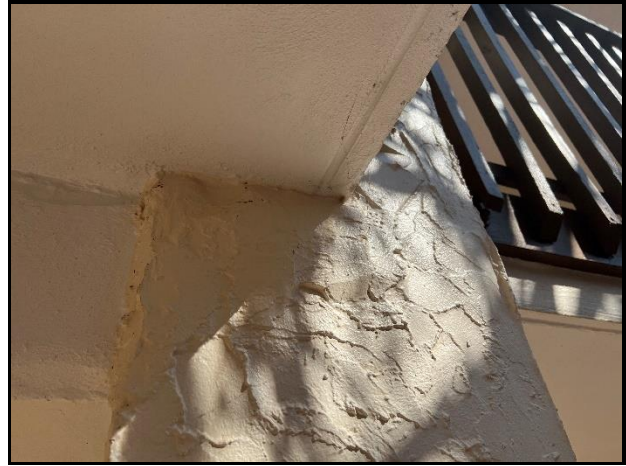
Minor concrete spall located at the top of a column in the courtyard.

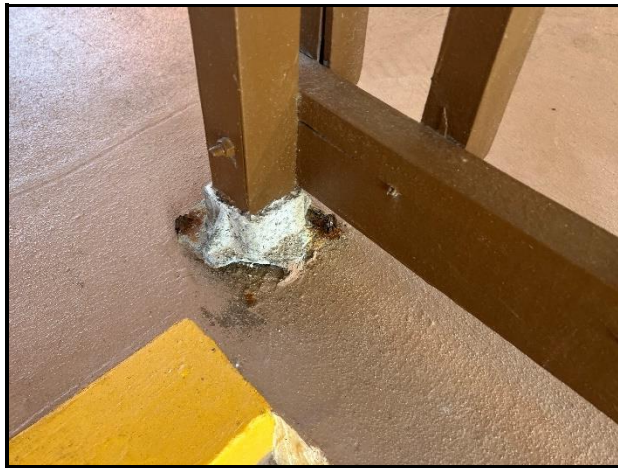
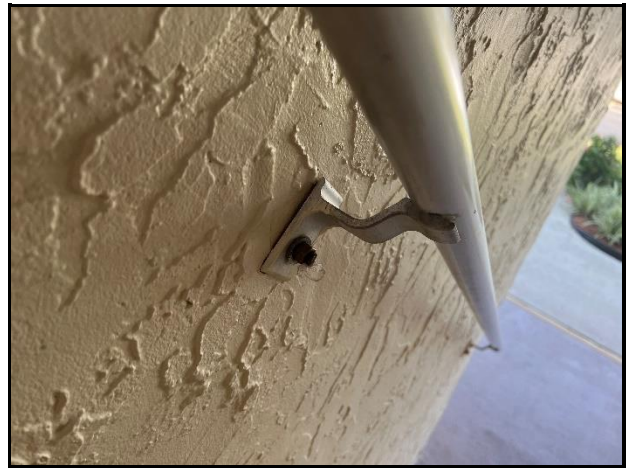
Additional Comments:
Handrail on the West stairwell is loose from the wall. Wood guardrail on the third level has loose and/or broken bottom brackets.

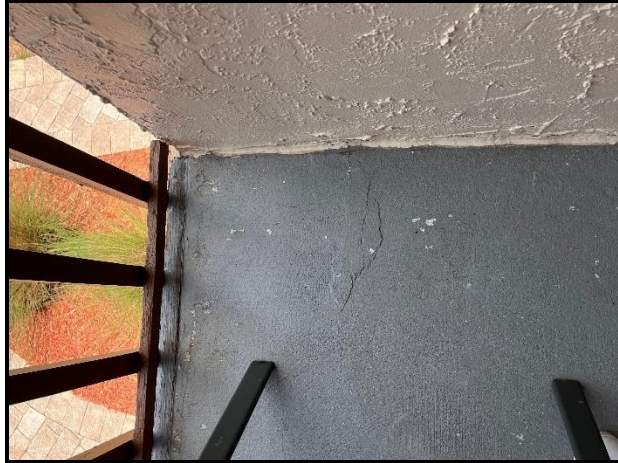
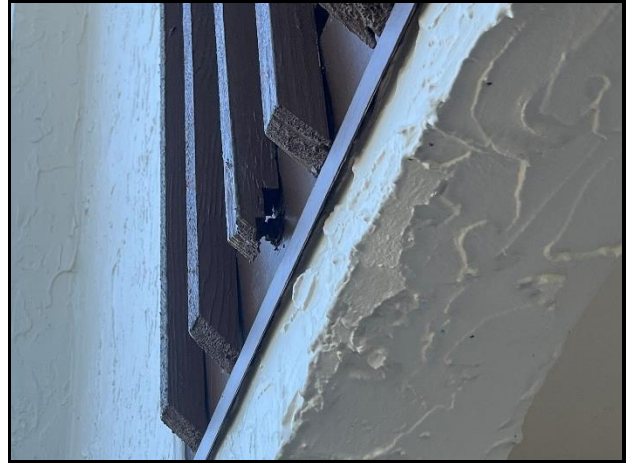
Additional Comments:
Some attachment bolts have moderate to severe corrosion. A concrete spall was noted on the balcony of unit 1206.

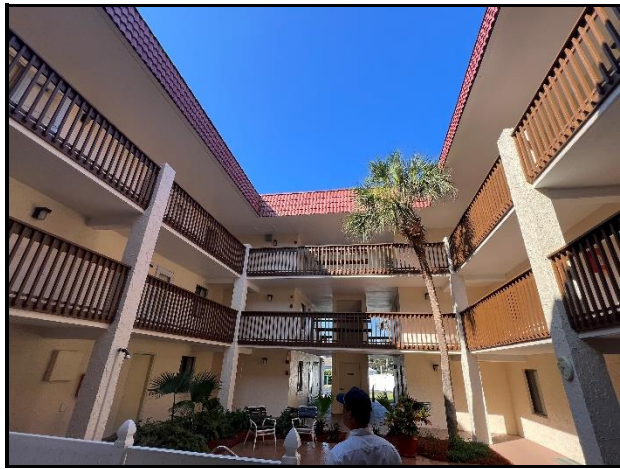
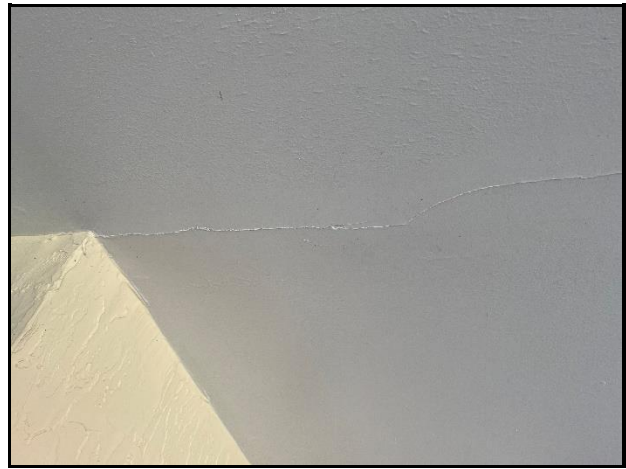
Additional Comments:
Some railing attachment bolts have moderate to severe corrosion. A minor concrete crack was noted in the ceiling.

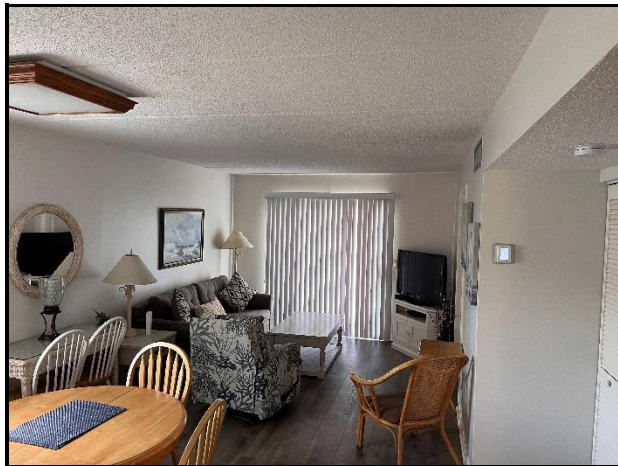
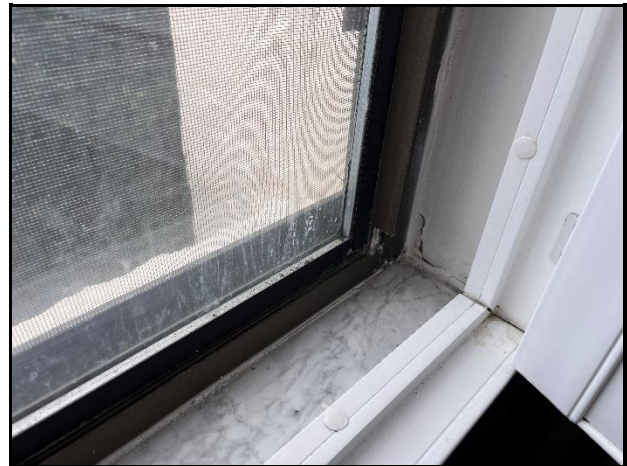
Additional Comments:
Sealant separation at windows was observed.

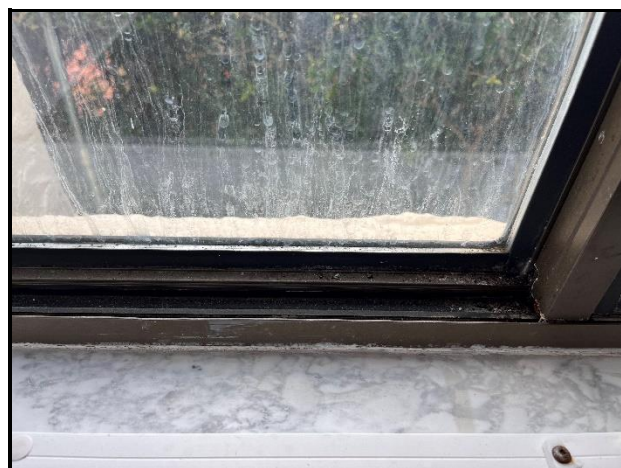
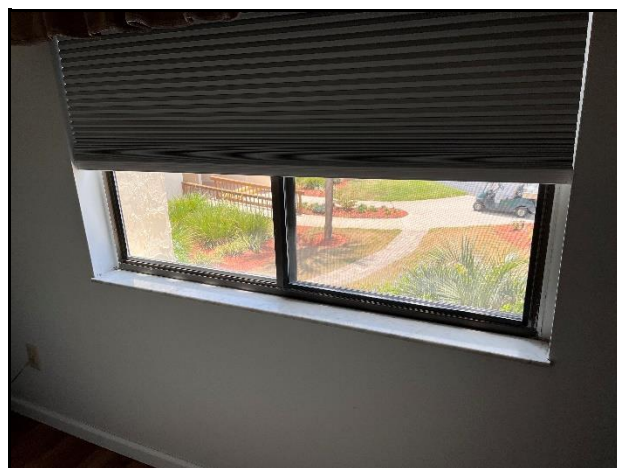
Additional Comments:
Original windows are beyond their useful life. Consideration for replacement is recommended.

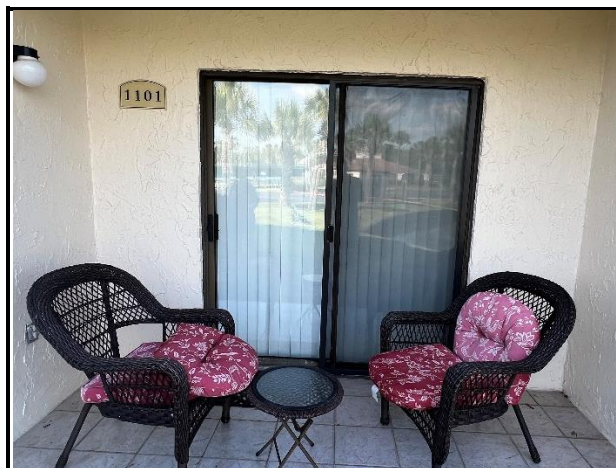
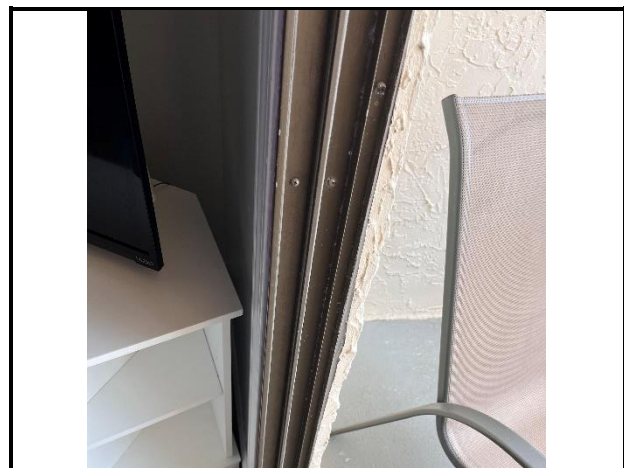
Additional Comments:
Original doors are beyond their useful life. Consideration for replacement is recommended.

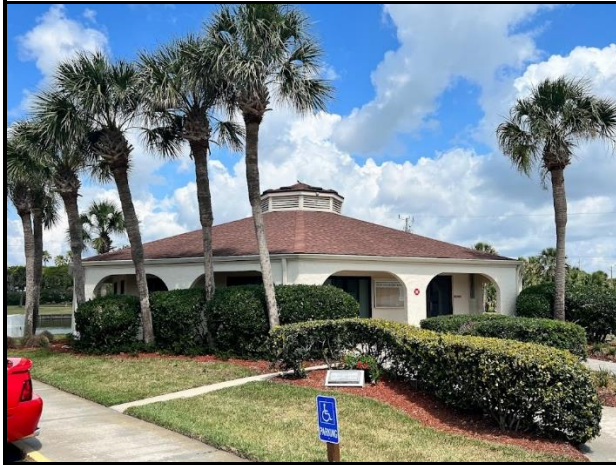
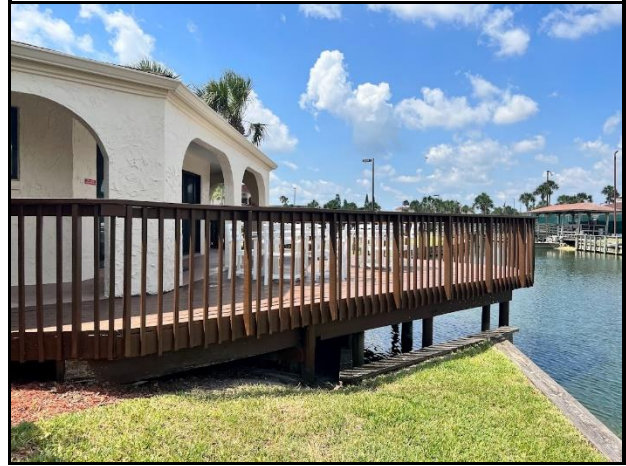
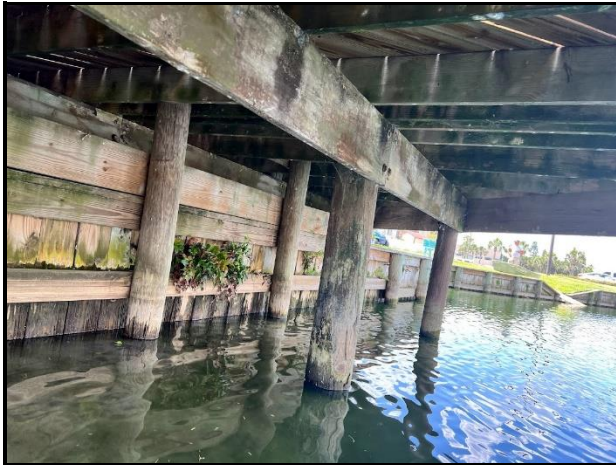
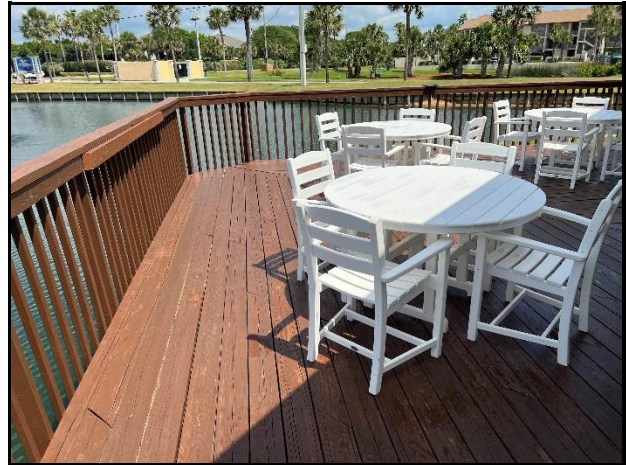
Additional Comments:
Loose guardrail and deck boards on deck.
