Milestone Phase One Inspection Report
 Ocean and Racquet Condominium Association - Building 4

June 30, 2023

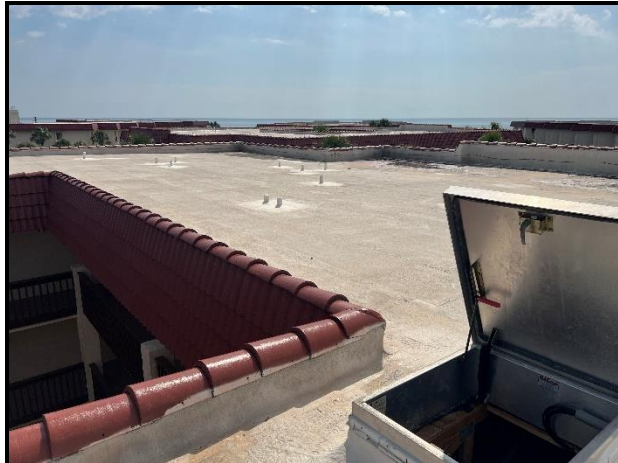
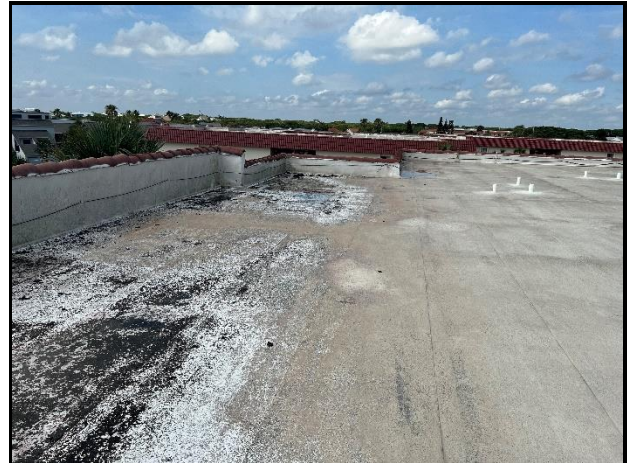
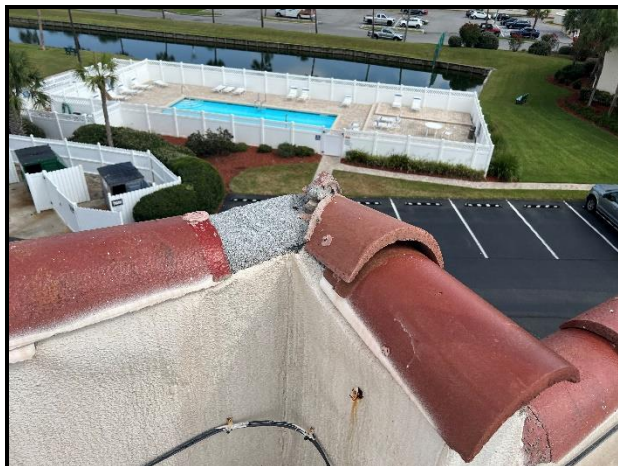
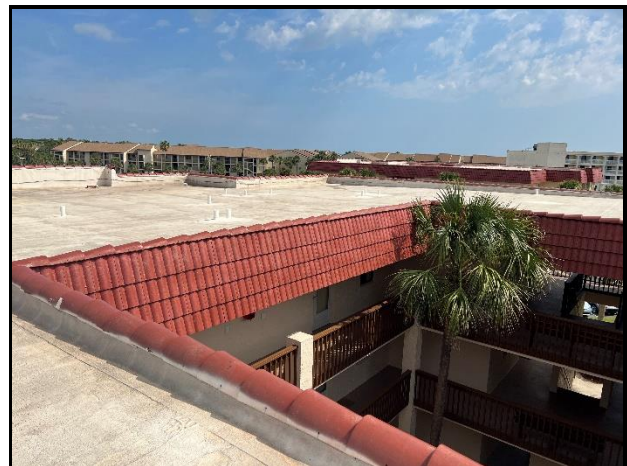
The roof of building 4 had some ponding noted in one area. There were a couple of missing and/or broken tiles. Also, the roof access hatch opens very close to the edge of the roof, a guardrail is recommended in the area.

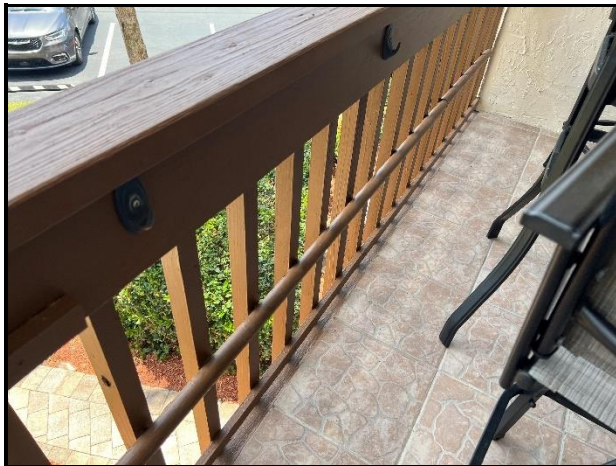
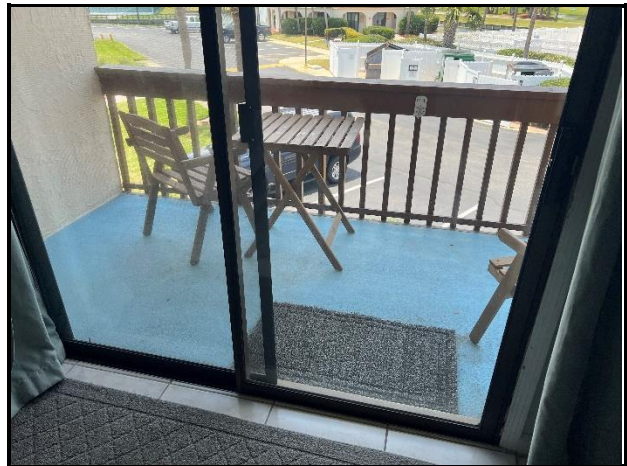
Additional Comments:
Some attachment bolts have moderate to severe corrosion.

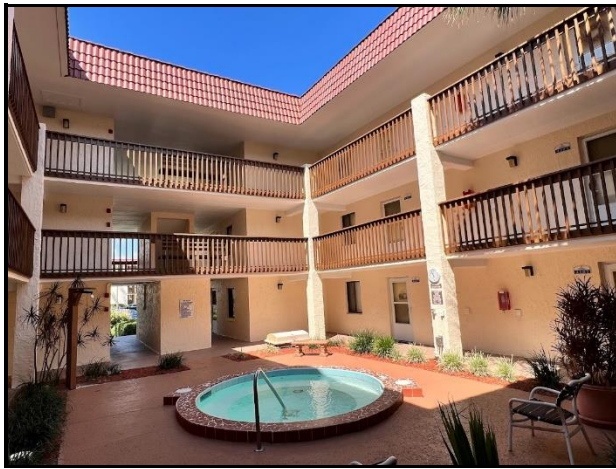
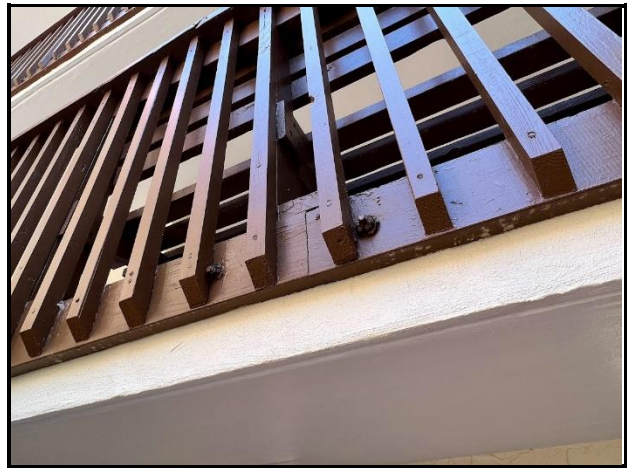
Additional Comments:
Some attachment bolts have moderate to severe corrosion.

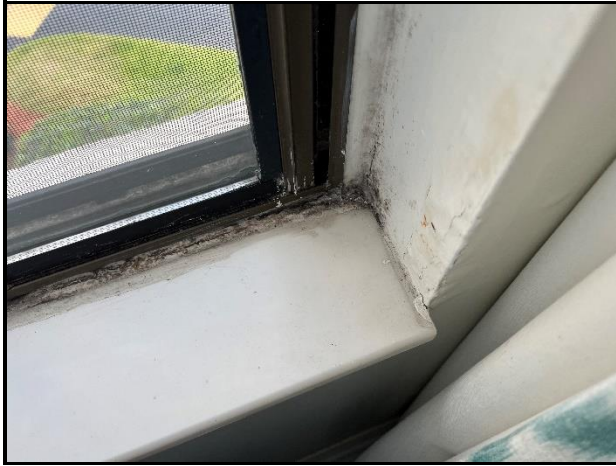
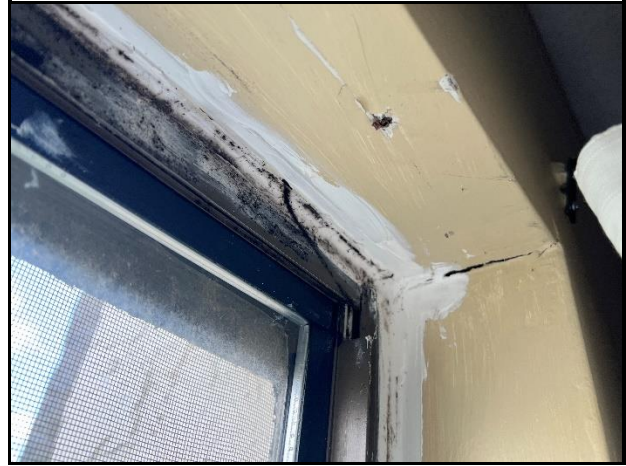
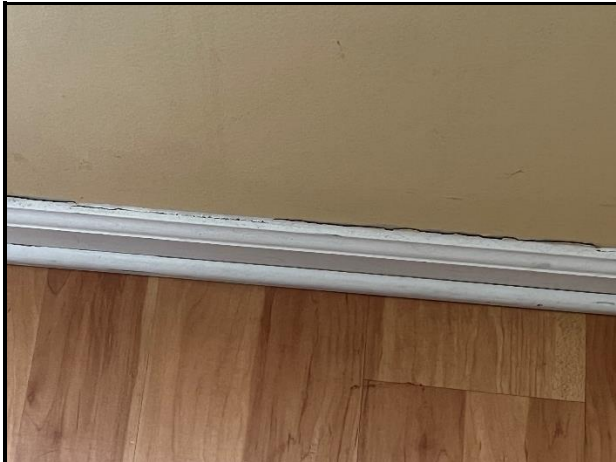
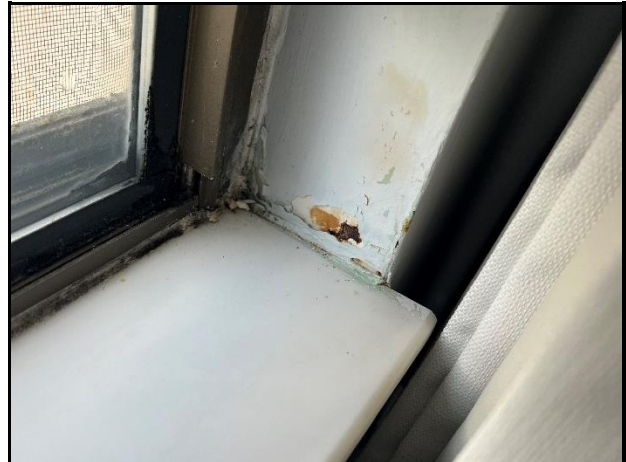
Additional Comments:
Windows in building four showed signs of water intrusion and separated sealants. Some separation of baseboard, a sign of water intrusion, was seen in units including 4107.

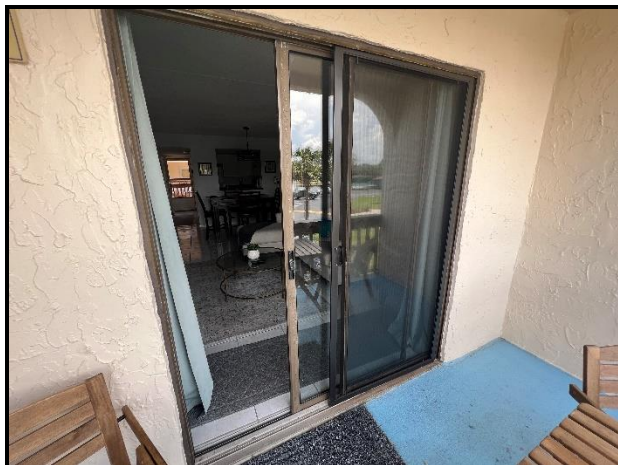
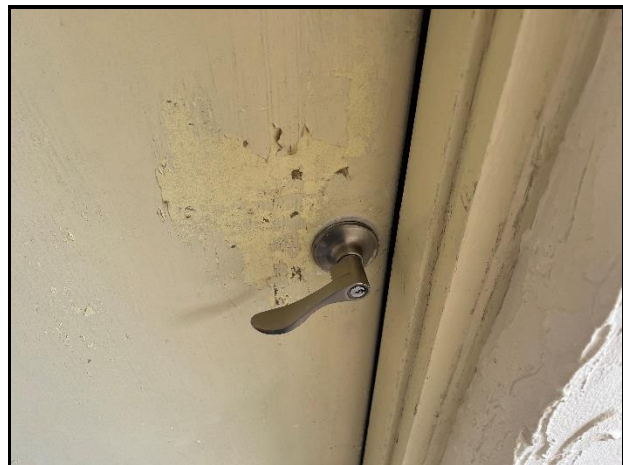
Additional Comments:
Original doors are beyond their useful life. Consideration for replacement is recommended.
