Update "No-Site-Visit" Reserve Study

St. Augustine Ocean & Racquet Club St. Augustine Beach, FL

Report #: 26693-4
For Period Beginning: October 1, 2019
Expires: September 30, 2020

Date Prepared: August 9, 2019

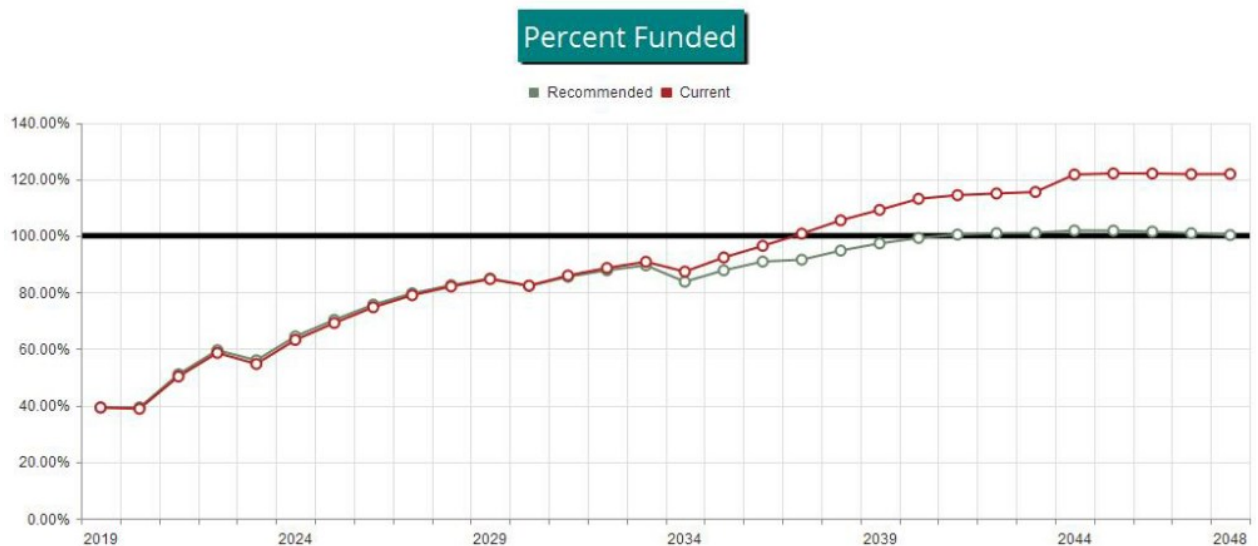
Figure 4

This figure shows the same information described above, but plotted on a Percent Funded scale. It is clear here to see how your Reserve Fund strength approaches the 100% Funded level under our recommended multi-yr Funding Plan.
