Milestone Phase One Inspection Report

Ocean and Racquet Condominium Association - Building 2

June 30, 2023

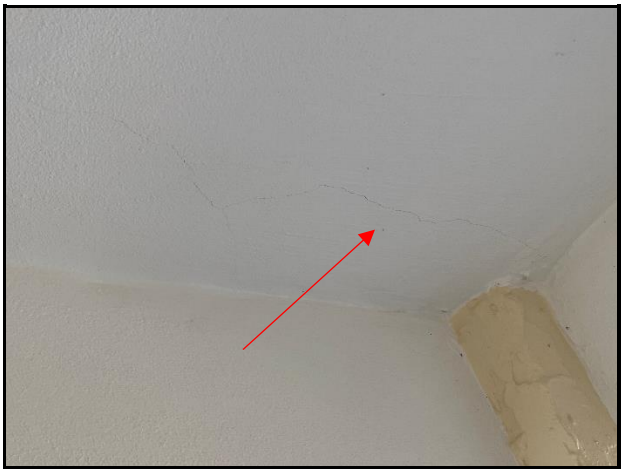
Photograph 9.

Additional Comments:
Concrete spall in the walkway beam and slab near unit 2203. Hairline crack in slab near unit 2205.

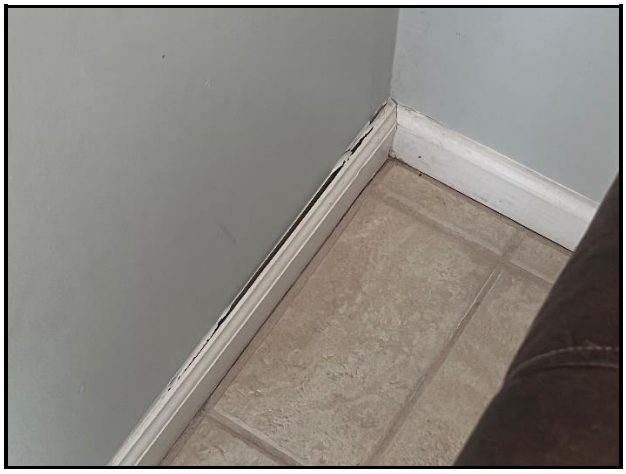
Photograph 11.

Additional Comments:
Unit 2106 has signs of water intrusion near the patio slider and the bedroom window. Separating sealants near patio/balcony doors.

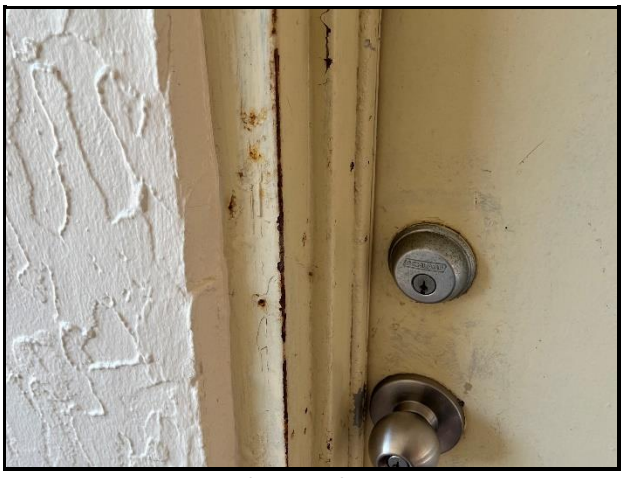
Photograph 15.

Additional Comments:
Original doors are beyond their useful life. Consideration for replacement is recommended.
