Milestone Phase One Inspection Report

Ocean and Racquet Condominium Association - Building 7

June 30, 2023

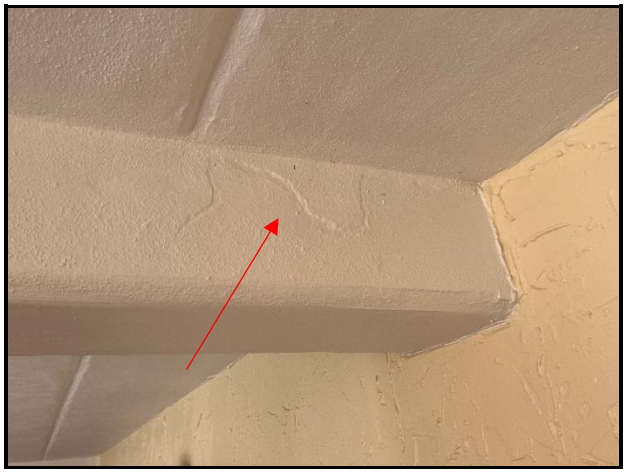
Photograph 7.

Additional Comments:
Minor concrete spalls were noted in beams near units 7104 and 7203 and in the slab near unit 7206. The ceiling of the 3rd floor is sagging at the Southeast corner. Guardrail fasteners have signs of corrosion ranging from moderate to severe.
